# PANTOCAM

## PANTOGRAPH WEAR AND DEFECT MONITORING

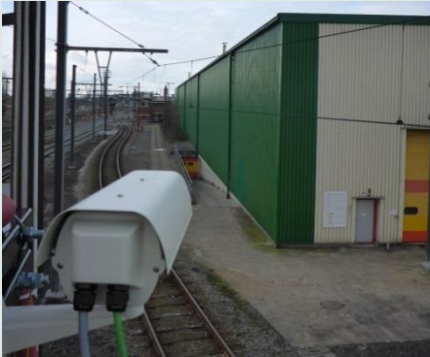
The PANTOCAM system is specifically developed for the measurement of wear on pantographs and the detection of defects and damage on current collectors of heavy and light rail vehicles.

The system inspects the vehicles during an in service pass-by, thus eliminating the need to take vehicles out of service for human inspection. This enables the evaluation on a daily basis of all vehicles, whilst at the same time minimizes failures and allows lowering the pantograph rejection limits.

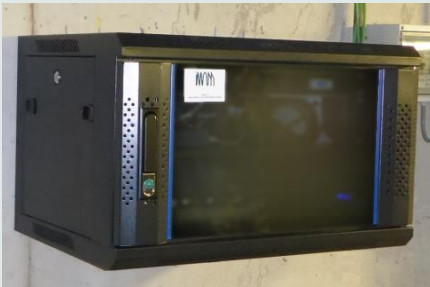
#### Computing unit

A 19" server rack houses an industrial computing unit and the power supplies for the cameras. The rack is installed in the vicinity of the track, up to a distance of 100 m. The rack is installed indoors. If installed outside, the rack should have a protected environment that is waterproof and heated/air-conditioned. All cabling runs directly from the cameras to this rack. The rack is hooked up to the power grid and connected to the internet (data).

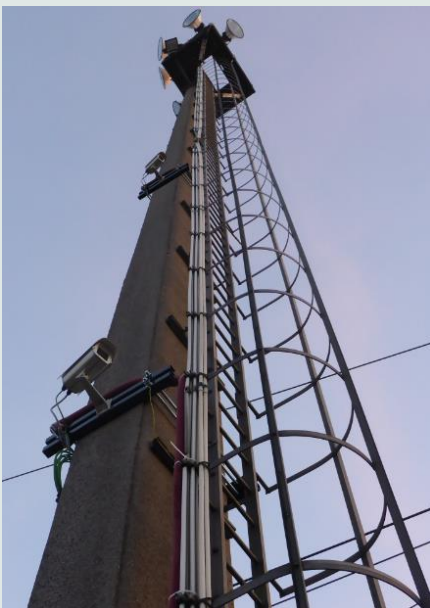
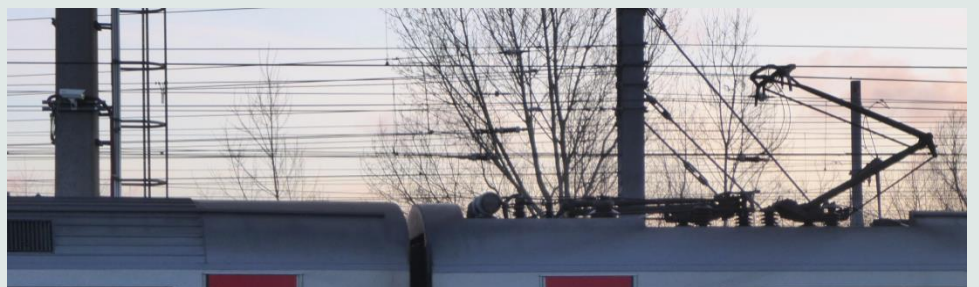
The system consists of two motion-triggered cameras. One is mounted at the height of the overhead line to inspect the wear of the pantograph. The second is mounted higher at approximately 10 m and looks for damage and defects. The second camera also enables vehicle identification.

Global shutter technology is incorporated in the cameras. This enables the system to make very sharp, non-deformed images of moving vehicles.

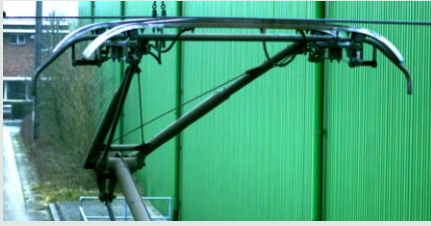
The operator manually processes the collected data sets through the system software. Measurements of critical dimensions are executed by selecting the best image out of the collected images. The software is designed to perform a pixel measurement of a vertical reference and of the contact strip. Hereafter the software automatically calculates the remaining thickness of the contact strip. The operator can also perform a damage and defect check on the recorded imagery. Hereafter the results are saved in the PANTOCAM SQL database, allowing trending and condition-based maintenance.

Hoogte drager (px) 10  
 Hoogte koolsteepstuk (px) 11  
 Hoogte koolsteepstuk (mm) 23.1

De resterende dikte van het sleepstuk "sleetgrens in dienst" is bereikt.  
 Er is een gedeelte van het koolstuk verdwenen of beschadigd.  
 (Kasperowski koolsteepstukken) Er is geen actieve kopermantel meer aanwezig.
